## Acute ruptured hemorrhagic ovarian cyst: CT findings in a life-threatening presentation

### Abstract

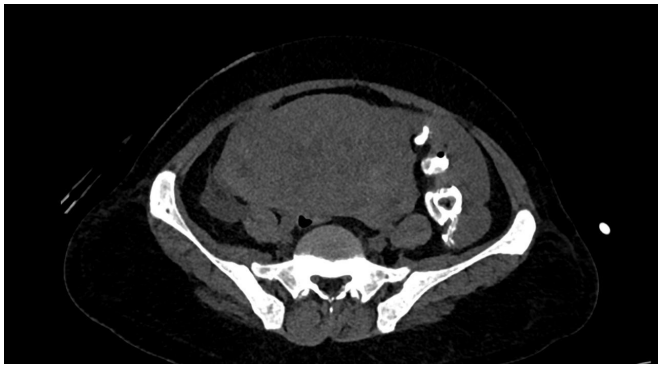
**Figure 1:** Non-contrast axial CT showing a cystic right adnexal lesion with hyperdense hemorrhage and associated pelvic free fluid.

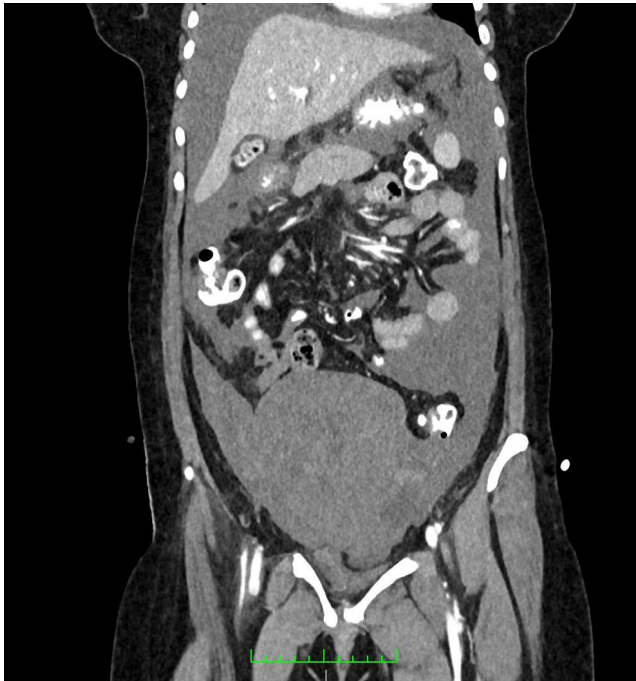
**Figure 2:** Coronal portal venous phase CT demonstrating the vertical extent of the adnexal cystic lesion and hemoperitoneum.

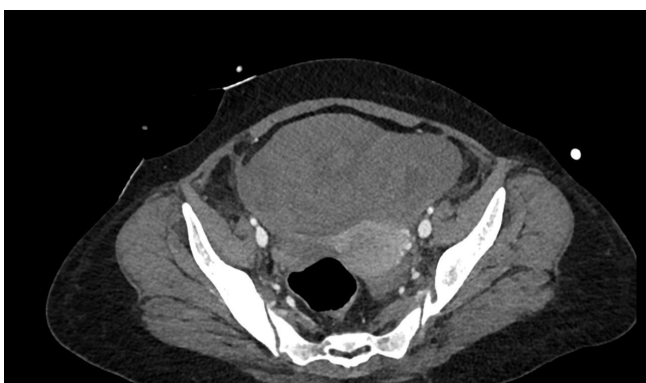
**Figure 3:** Axial portal venous phase CT showing internal clot and a thin, minimally enhancing cyst wall.

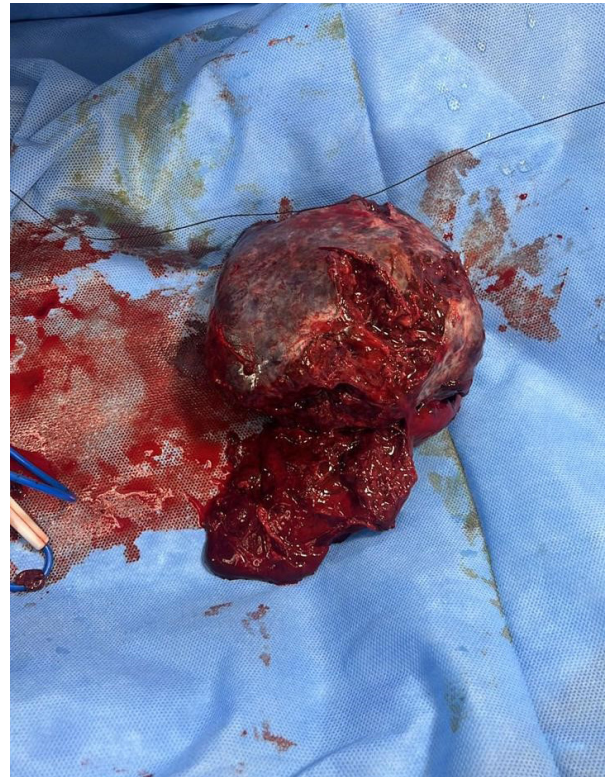
**Figure 4:** Intraoperative specimen of the ruptured hemorrhagic ovarian cyst with adherent clots.

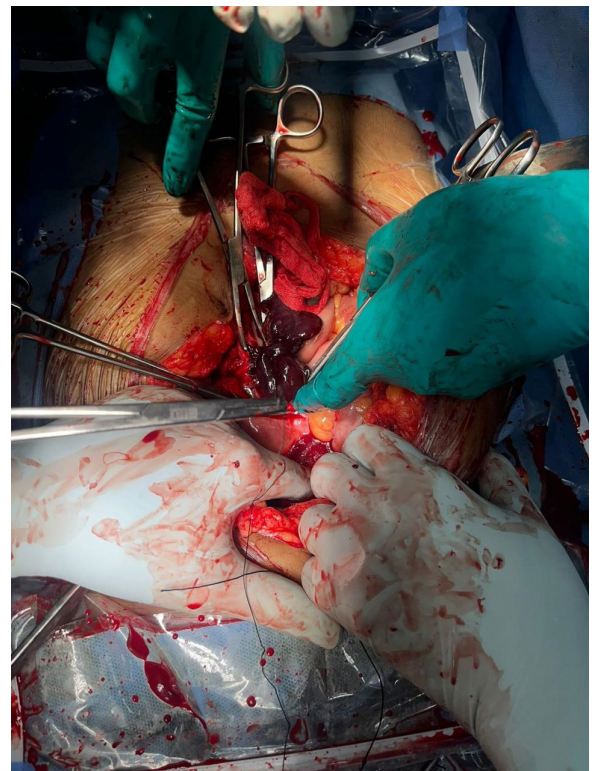
**Figure 5:** Intraoperative photograph showing hemoperitoneum and active pelvic bleeding.
